# Towards better design and management of tsunami evacuation routes: a case study of Ao Jak Beach Road

ALAN D. ZIEGLER<sup>1\*</sup>, ROY C. SIDLE<sup>2</sup>, MANDY S. SONG<sup>1</sup>, ZUO JIN ANG<sup>1</sup> & DECHA DUANGNAMON<sup>3</sup>

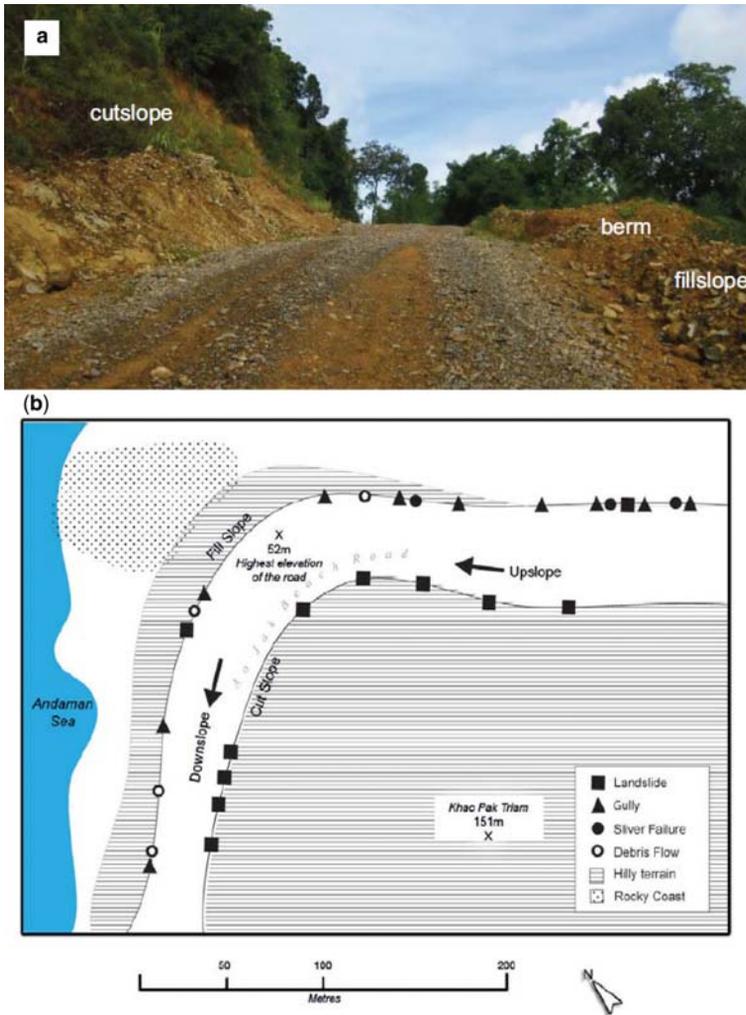
Such an approach requires the excavated material to be carefully incorporated and compacted into the outer portion of the road prism (Fig. 3a). However, material excavated from the hill-slope during widening of the Ao Jak Beach Road was simply pushed to the outer side of the road prism where it created a berm, as well as a bed of unstable material on the fill-slope (Figs 2a & 3b). Some of the excavated material was incorporated onto the running surface of the road; other material remained near the cut-slope and some was eroded down-slope (Fig. 2). In general, no provisions were made for managing road drainage. Runoff water flowing on the road surface or within the inside ditch of the road prism was allowed to exit onto fill-slopes, which were inadequately prepared to receive runoff.

**Fig. 2.** (a) Crest of the Ao Jak Beach Road. Coarse gravel has been placed on the surface to improve traction. Unconsolidated material forms a berm on the fill-slope (right-hand side) after being excavated from the cut-slope (left). (b) Location on the Ao Jak Beach of observed landslides (boxes); debris flows (hexagon); sliver failures (circles); and gullies (stars). The road width is not drawn to scale.

The creation of a berm on the outside edge of the road should be avoided, as these features have the tendency to concentrate runoff, thereby increasing the likelihood of slope failures or gulying when the flow is finally discharged onto the hill-slope. On slopes exceeding  $6^{\circ}$ – $7^{\circ}$ , in-sloped or crowned roads with cross drain culverts, placed at appropriate distances, would help eliminate the development of high volumes of concentrated overland flow on the road surface (Keller & Sherar 2003). Ideally, inside ditches should be lined to prevent incision. Properly designed outlets with rock protection should be located on the fill-slope side to prevent

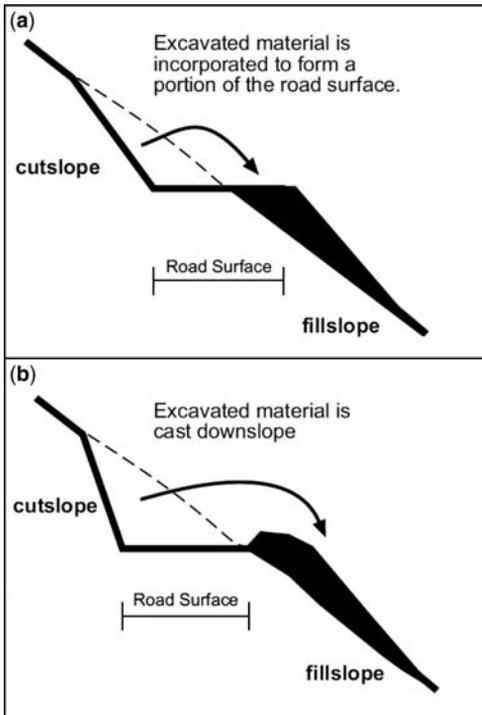
**Fig. 3.** (a) A balanced cut-and-fill road construction technique that incorporates compacted, excavated hill-slope material into the fill-slope to form a substantial portion the road width. (b) During road widening at Ao Jak, excavated material was side cast onto the fill-slope rather than being incorporated into the design of the operating portion of the road (adapted from FAO 1998).

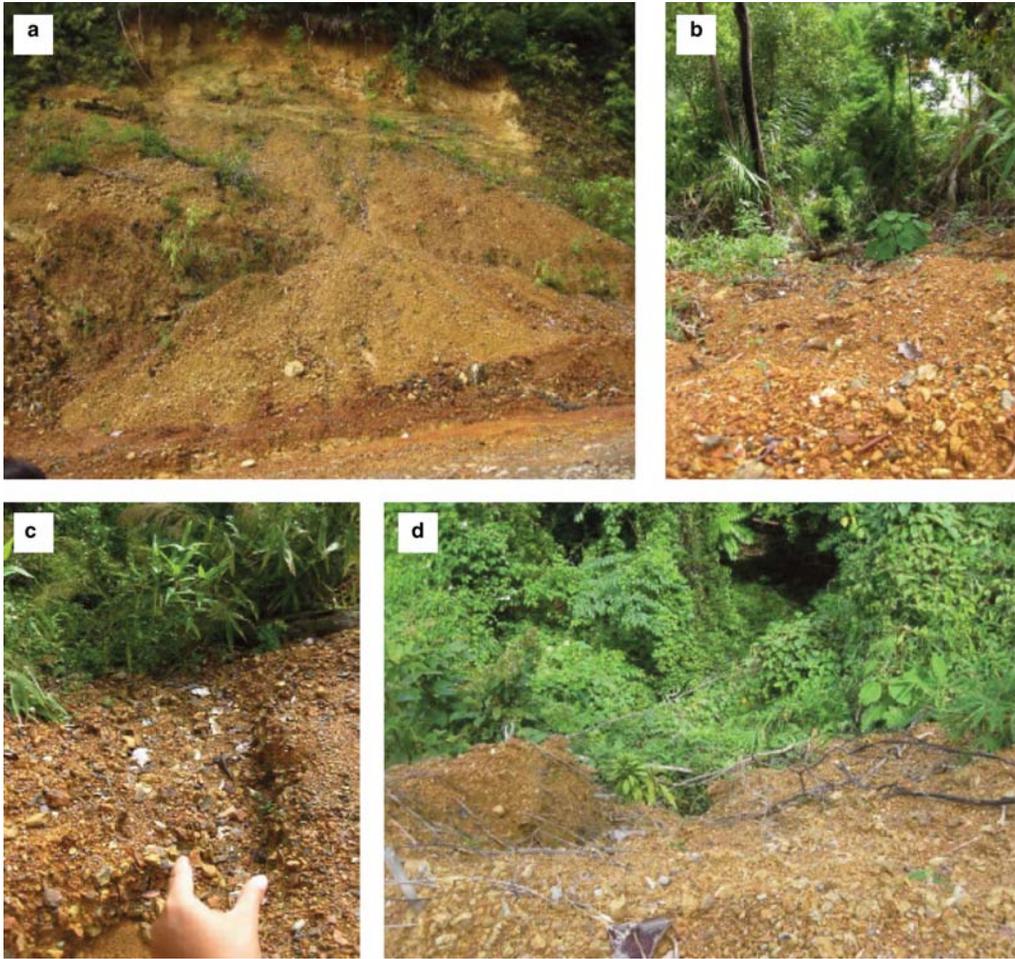
**Fig. 4.** Slope failures and gullies on the Ao Jak Road: (a) landslide along a cut-slope; (b) debris flow on a fill-slope; (c) sliver failure in fill-slope material; and (d) gully formation from overland flow incising a rill on unconsolidated fill-slope material.

fan-shaped talus slope at the base (Fig. 4a). Because most landslides occurred on cut-slopes, mobilized material was often deposited on the road surface or carried across the road and deposited on the fill-slope.

The four debris flows that accounted for 389 m<sup>3</sup> of sediment all occurred on the fill-slope (Table 2; Fig. 4b). These rapid mass-wasting features are characterized as a liquefied mass of sediment flowing down-slope with no scarp at the head of the failure. Sliver failures accounted for only about 40 m<sup>3</sup> of material mobilized (Fig. 4c). Both debris flows and sliver failures occurred on relatively steep slopes of 30°–45° (Fig. 5). The 10 measured gullies originated from rills that were incised by concentrated overland flow (Fig. 4d). They occurred across a wide range of slopes

The estimated volume of material mobilized by nine cut-slope landslides was 2136 m<sup>3</sup>, compared with 528 m<sup>3</sup> removed by 19 fill-slope failures and gullies (Table 2). Landslides, in particular, occurred on the unstable, oversteepened cut-slopes. In contrast, debris flows occurred exclusively on fill-slopes, where failure of unconsolidated material was triggered by the inflow of concentrated overland flow together with gravitational stresses on the steep unconsolidated slopes. Although numerous fill-slope failures were present, the volume of mobilized material was limited by the availability of unconsolidated material. Despite the disparity in the number and severity of degradation features above and below the road, all collectively threaten

2006). Where possible, roads should not cut into steep and unstable slopes because of the risk of destabilizing the hill-slope. Our measurements showed that the largest volume of material came from cut-slope failures, and that these features often trigger fill-slope failures. Thus, consideration must be given to constructing cut-slopes at stable angles or in more stable substrate, based on the geotechnical properties of the hill-slope materials. For example, for the fractured sandstone found along the Ao Jak Road, a proper slope ratio (horizontal:vertical) would be 1:1–1.5:1 (Keller & Sherar 2003). Cut-slopes may also need to be stabilized with rock buttresses, gabions or mechanically stabilized earth structures (Keller & Sherar 2003). However, expensive mechanical stabilization structures along such secondary roads are generally prohibitively expensive, particularly in developing nations.

Fill-slope failures, such as those observed along the Ao Jak Road (Fig. 5), may be avoided by utilizing full bench construction when slopes exceed  $30^{\circ}$ – $35^{\circ}$ . This would require moving some excavated material offsite, rather than simply casting it down the hill-slope. If full bench construction is not possible, a series of small benches could be constructed. Fills should be properly compacted; and retaining structures, reinforced fills and mechanically stabilized earth structures can be utilized to maximize stabilization (Keller & Sherar 2003).

The frequency and intensity of slope failures can generally be reduced by preventing the build-up of positive pore-water pressure through adequate drainage of interflow and surface water to geologically stable locations (Sidle & Ochiai 2006). In addition, the removal of protective vegetation should be avoided to help limit the generation of concentrated overland flow that may erode the fill-slope or undercut the cut-slope (Montgomery 1994). Concentrated road runoff is common in mountainous terrain: it may be generated by the interception of subsurface flow by the cut-slope or initiated on the consolidated road surface as an excess infiltration process during most rainfall events (Ziegler *et al.* 2001, 2007).

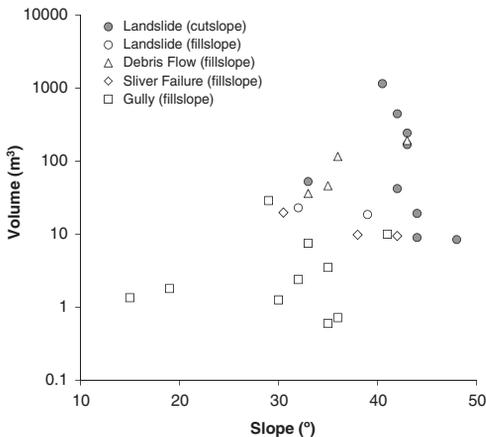
Landslides represented the largest volume of displaced material (2178 m<sup>3</sup>). Eight of the 11 landslides occurred on hill-slopes steeper than 40° (Fig. 5). Most of the landslides were shallow debris slides that were initiated during rainfall events. These slides were characterized by a distinct scarp at the head, a translational failure plane and a

**Fig. 5.** Relationship between failure type, location (cut-slope or fill-slope) and the total volume of material mobilized (Table 2). Cut-slope landslides, which mobilized the most material, typically occurred on the steepest slopes (filled circles).
